TO :	<b>CIAC</b>	Date:	09/03/2016
Attn. :		Pag. (incl.this page):	19
Fax :		Our ref :	PSEAW109/2016/46322/159424
Ref. :	A109C IETP A109C S/N 7629 Aircraft Damage Evaluation (Annex A)	From:	<b>AW109 Product Support Engineering</b>
		Phone:	+1 215-268-9151
		Fax:	+1 215-281-0447
		e-mail:	<a href="mailto:micael.menendez@finmeccanica.com">micael.menendez@finmeccanica.com</a>
Copy to:	AWPC109-119.PSE.mbx, Said Torres, Javier Matos		
<input type="checkbox"/> Urgent <input type="checkbox"/> For review <input type="checkbox"/> Please Comment <input type="checkbox"/> RSVP <input checked="" type="checkbox"/> For info			
<b>SUBJECT: A109C S/N 7629 (TT: 1341.6 FH) – Damage Assessment</b>

**ANNEX A**  
**A109C S/N 7629 Aircraft Damage Evaluation**

**Subject:** A109C S/N 7629 Aircraft damage evaluation**Company:** Corporacion de la Industria Aeronautica Colombiana CIAC – Bogotá COL.**Owner:** Aeronautica Civil de Colombia

**Aircraft Model:** A109C  
**Aircraft S/N:** 7629  
**Aircraft Reg. Number:** HK-3661G  
**Aircraft TT:** 1,341.6hrs  
**Aircraft Landings:** 1,319

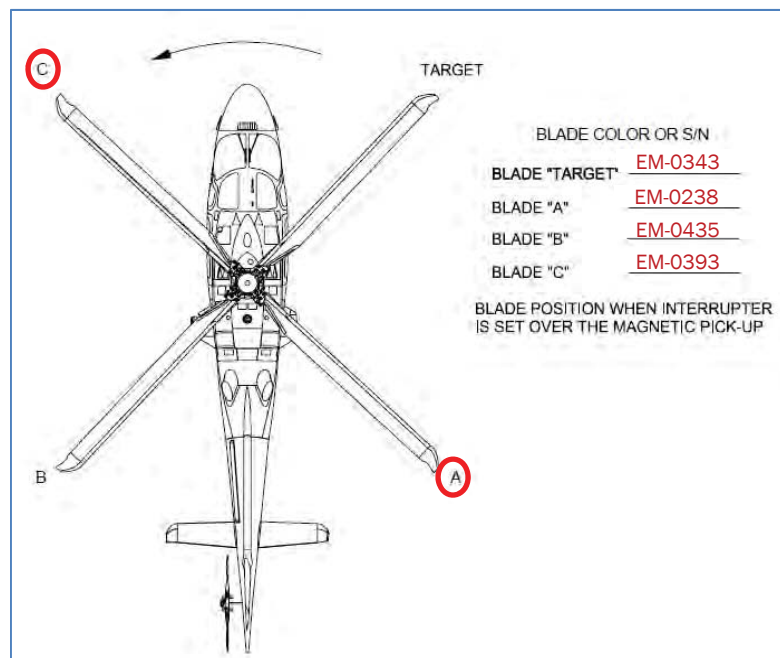
### M/R Oil Reservoirs condition:

Position	Condition
<b>Target</b>	Installed
<b>A</b>	Broken
<b>B</b>	Installed
<b>C</b>	Broken

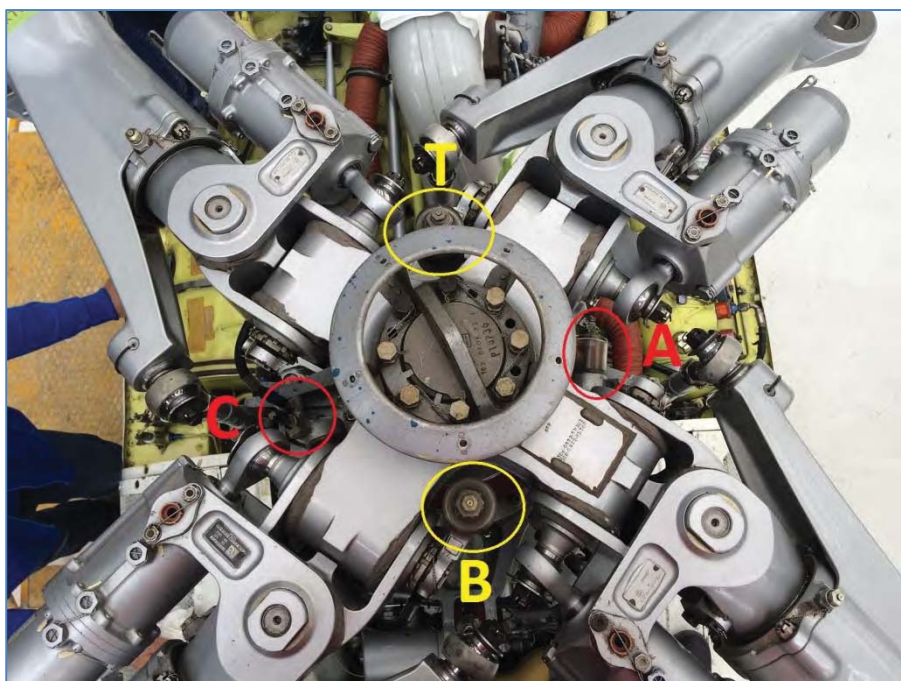
## Discoveries from damage pattern (Example of "C" Blade):

- Due mechanical damage found on Grip Assy P/N 709-0101-10-101 and Pitch link upper rod end 709-0101-18-105 is assumed the damper exceeded extension limits (retracting damper indicator pin position )

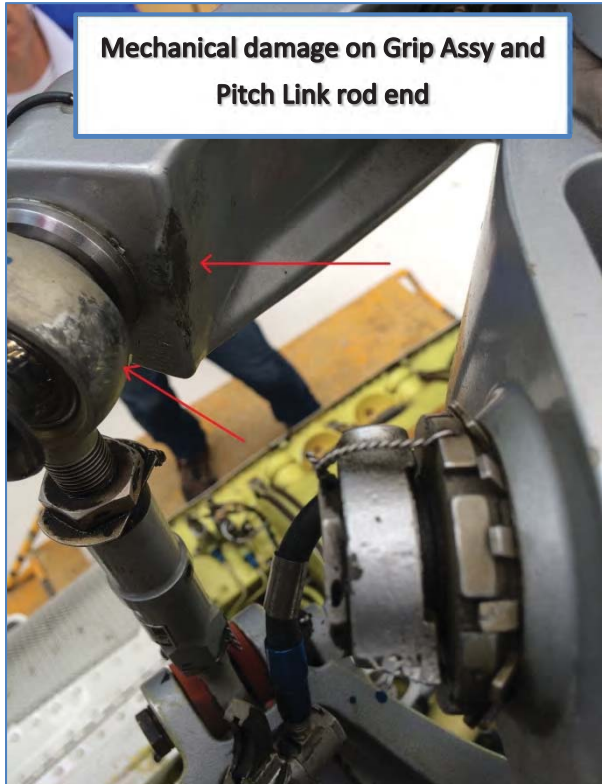
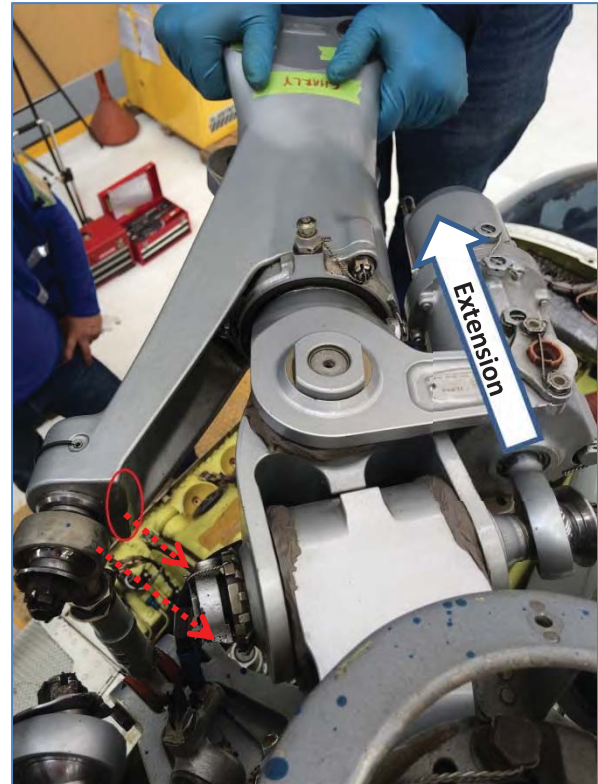
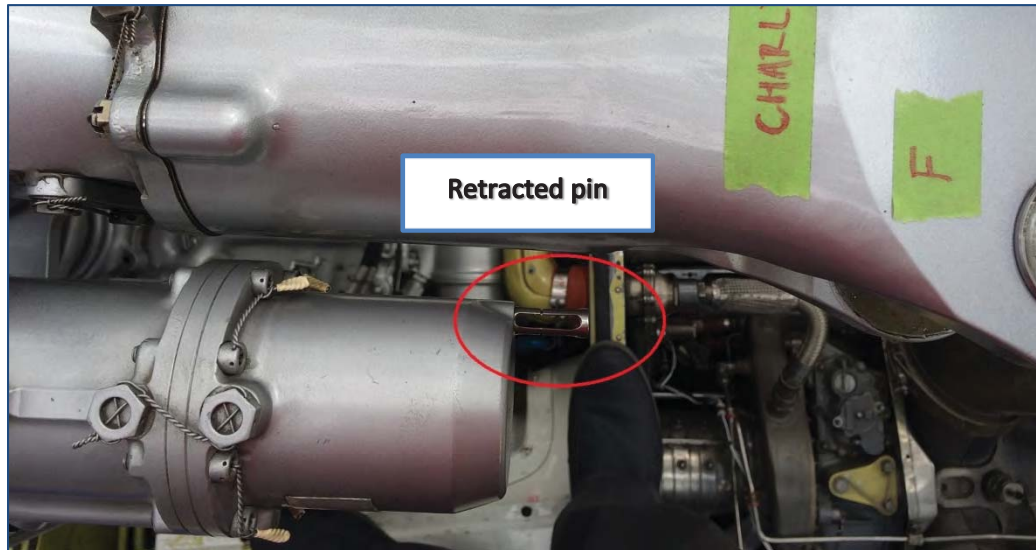
## Discoveries from damage pattern (Example of "C" Blade)... continue

- When Lag Damper extended, the Grip Assy and Pitch Link rod end impacted the Body Oil Reservoir Assy P/N 109-0102-03-5 and Bolt P/N 109-0102-06-3. Also both flat washers P/N 109-0101-65-1 impacted each other.

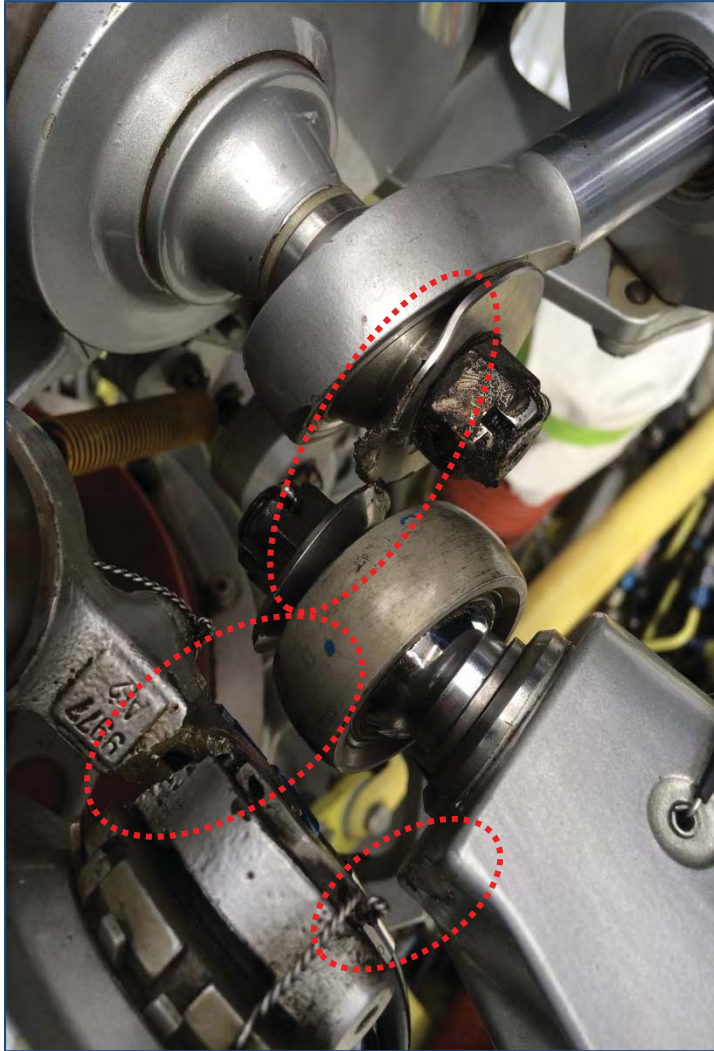
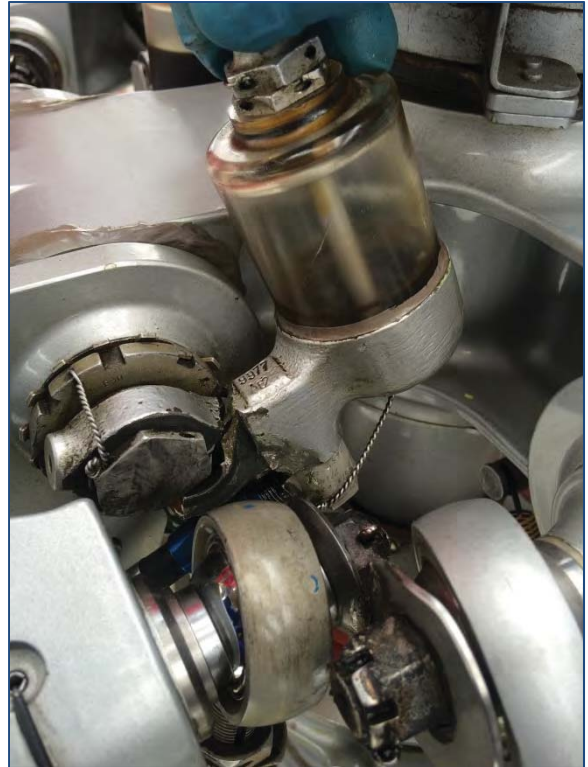
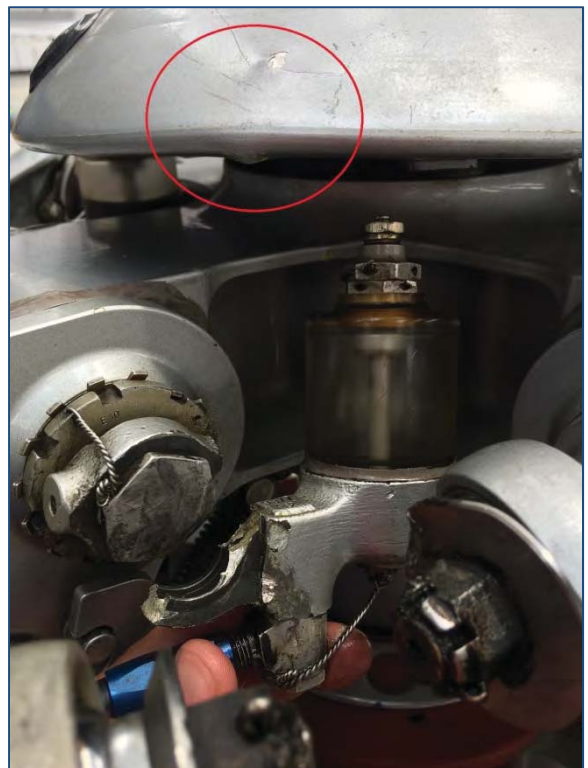
**Additional, this impact moves the Oil reservoir assy upward hitting the Fairing Cover P/N 109-0855-40-101**

Damages on Fairing Cover P/N 109-0855-40-101 (internal view)

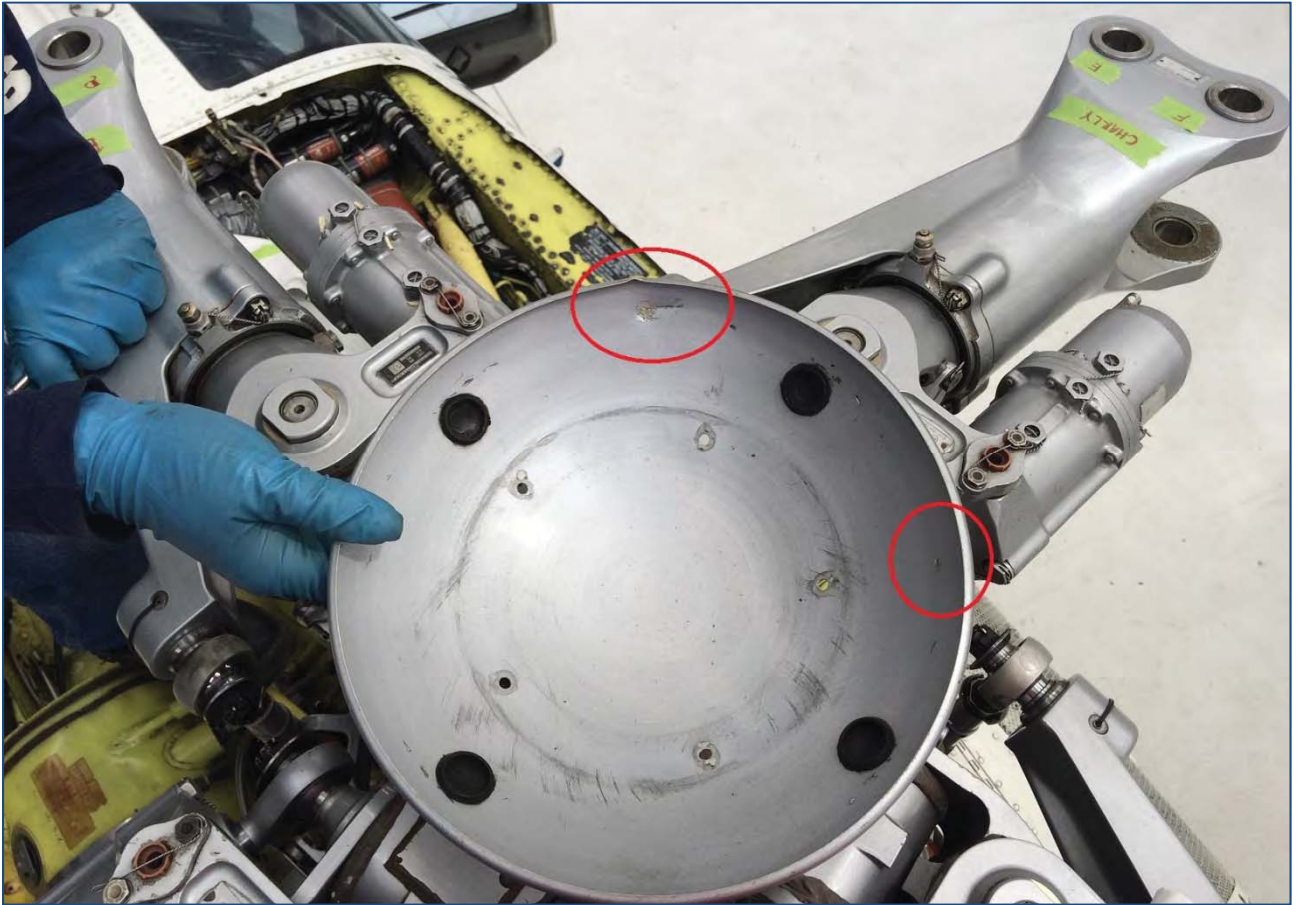
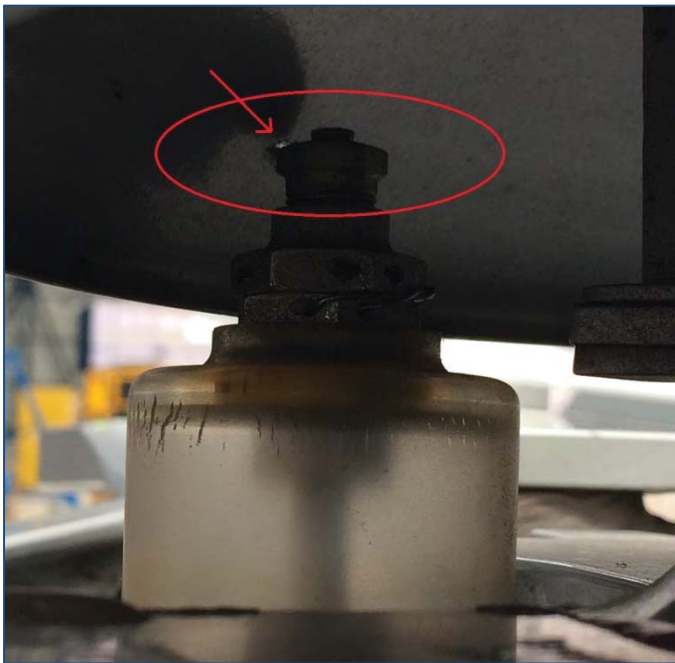
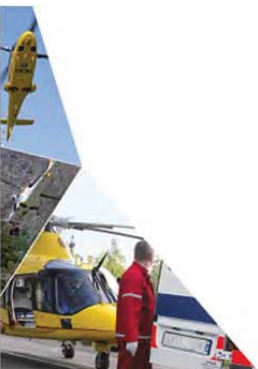
Same damage pattern on "A" Blade side.

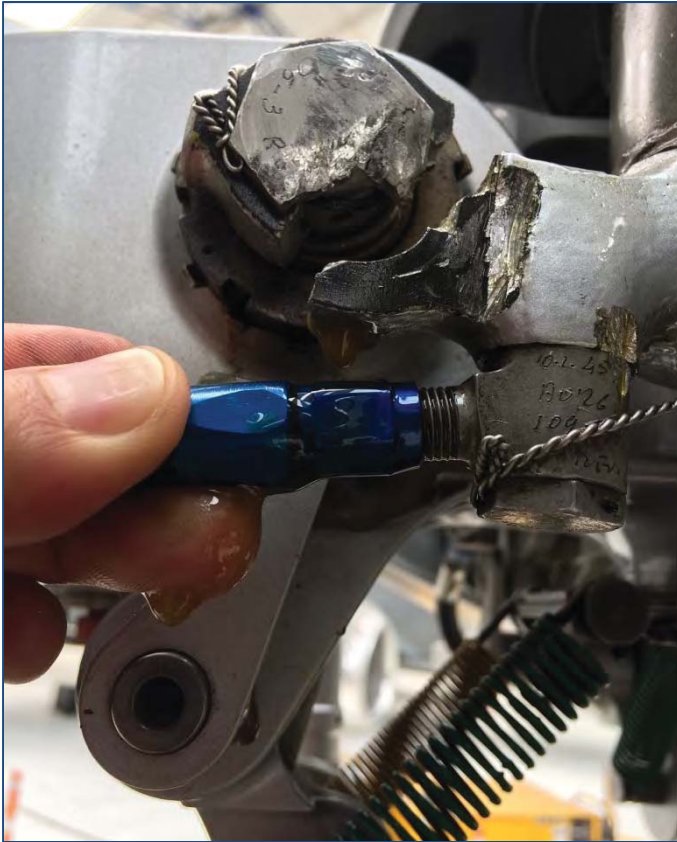
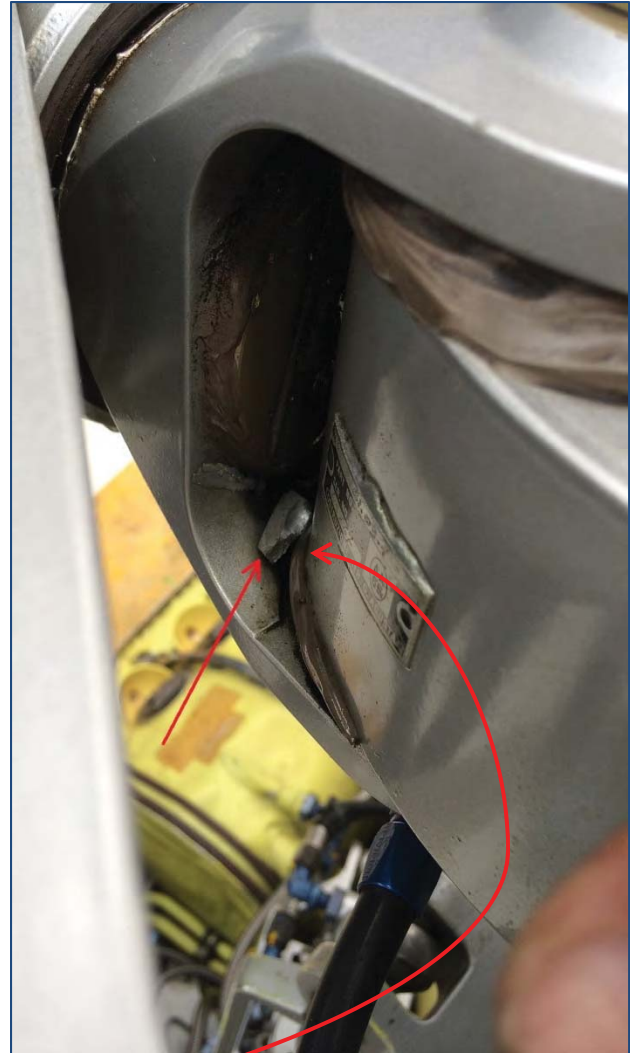
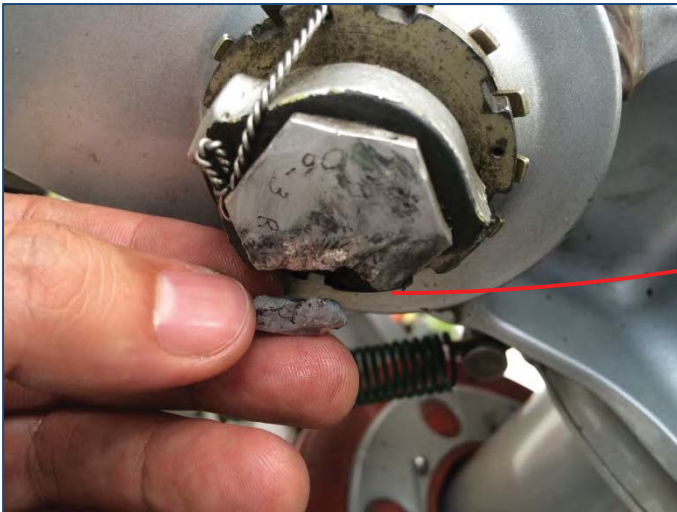
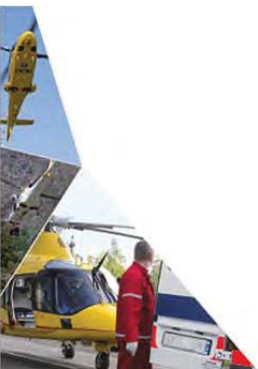
Oil Reservoirs didn't break

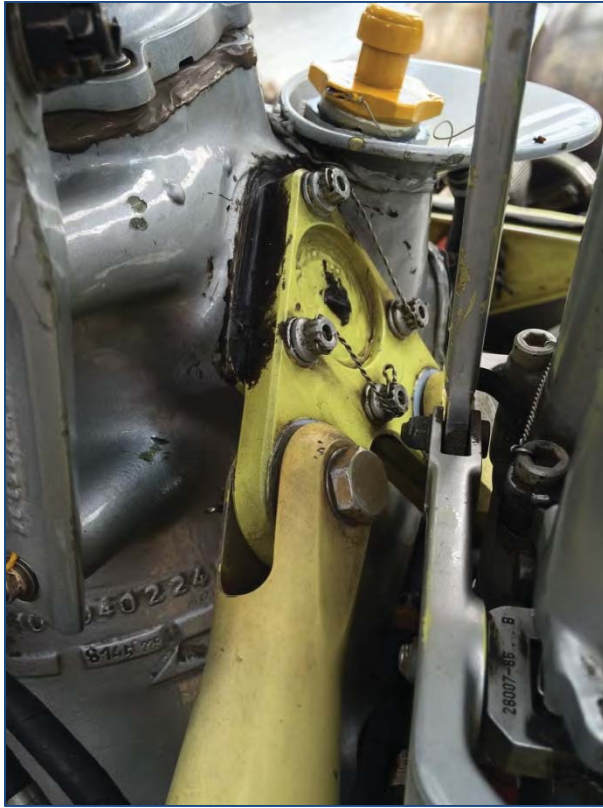
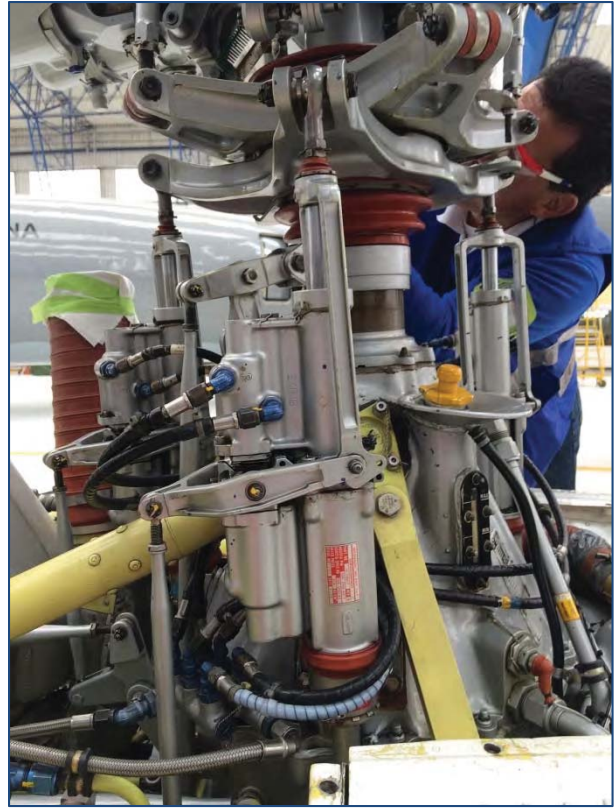
Evident fuselage damages in the MLG RH Support Assy area.

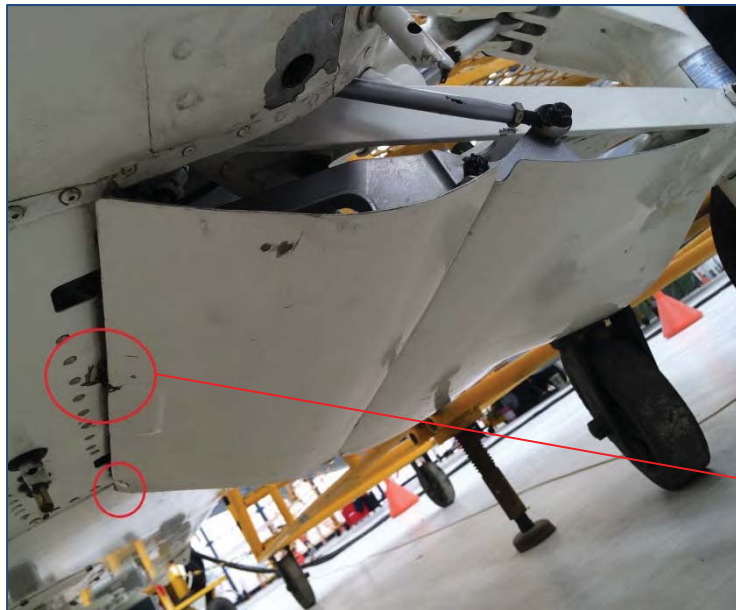
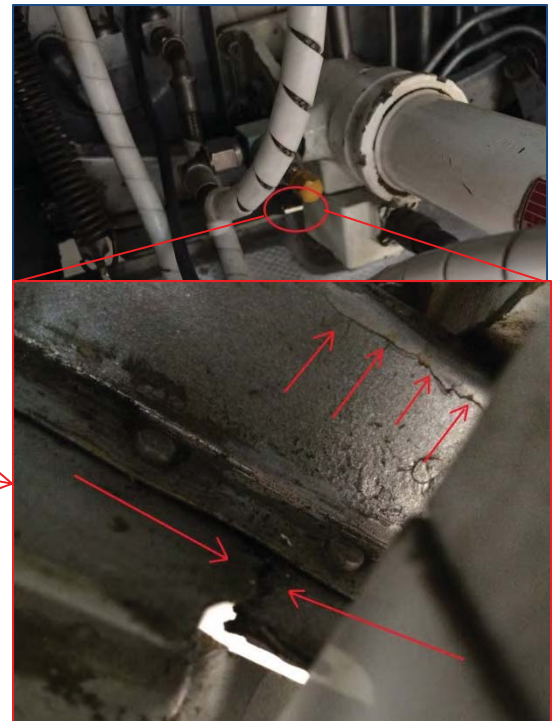
MLG Strut Shock Absorber Assy LH with 2 ½ in length against 1 ¾ in length on RH

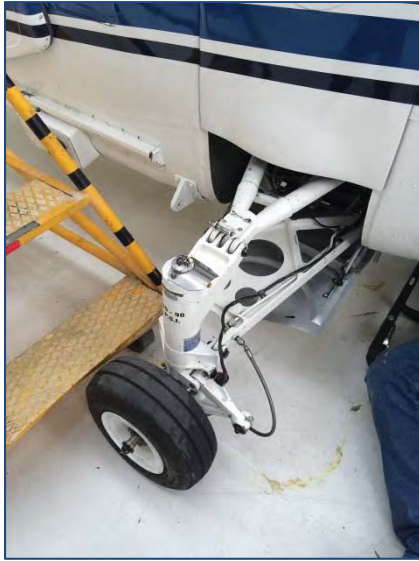
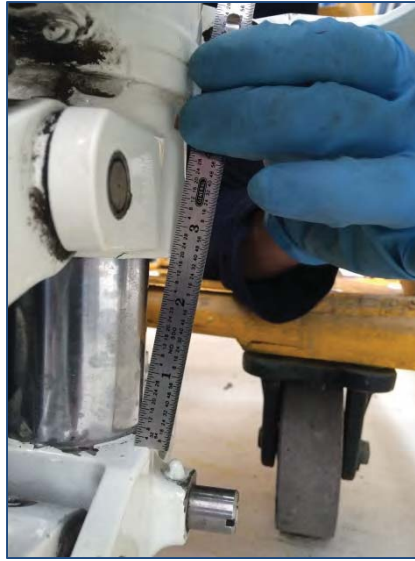
**MLG Strut Shock Absorber**  
**P/N 109-0502-86-103**  
**S/N MN23**

**Length: 2 ½ in**

**MLG Strut Shock Absorber**  
**P/N 109-0502-86-104**  
**S/N MN47**

**Length: 1 ¾ in**

1. After Nitrogen servicing on both MLG Strut Shock Absorber IAW MM, no leaks detected. Correct length reached.
2. No discrepancies noted on NLG Strut Shock Absorber, either in the attachment area.

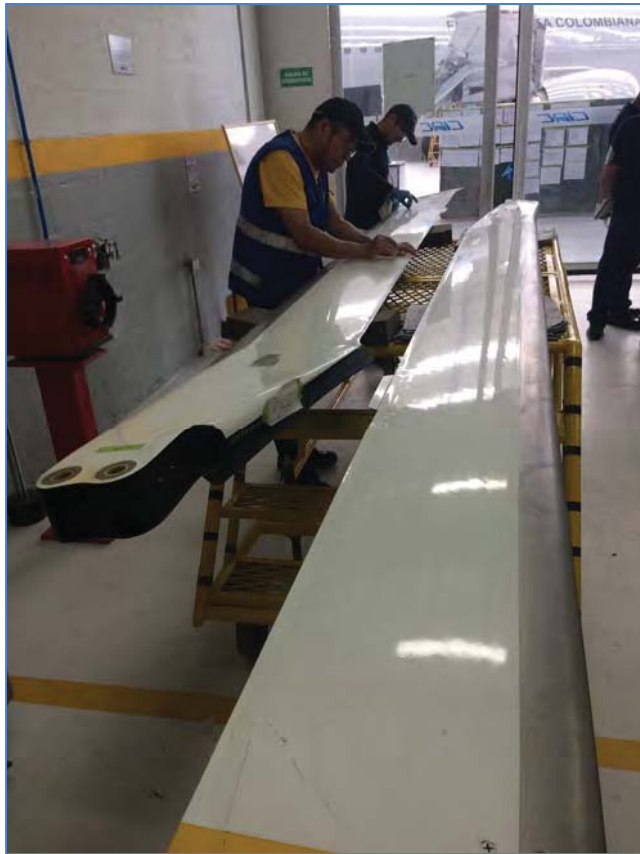
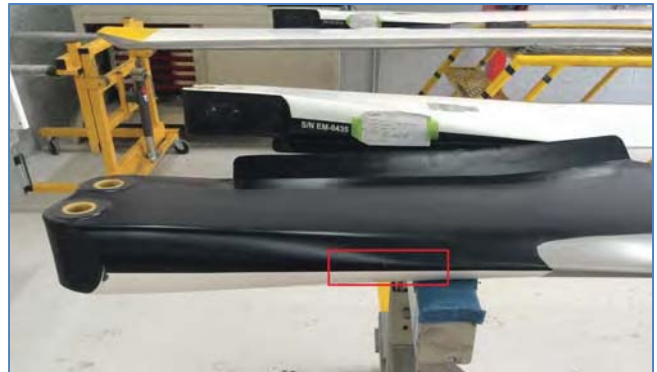
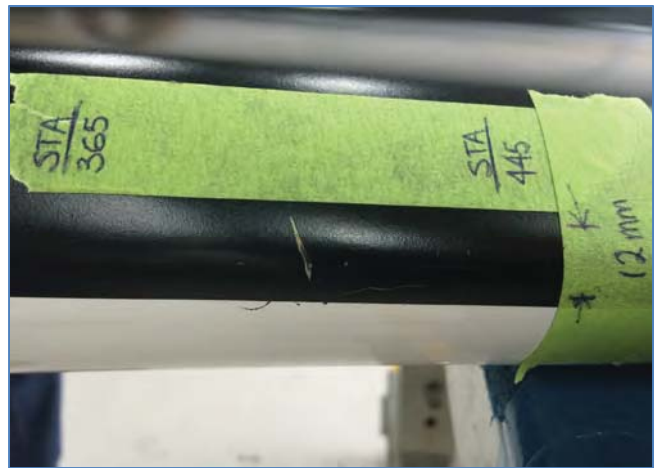
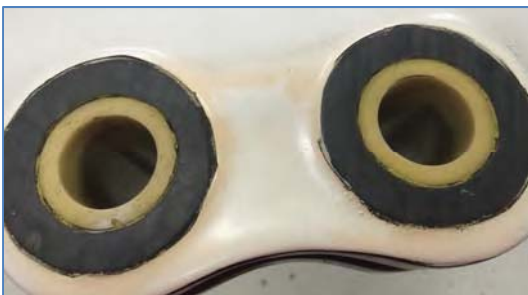
**Main Rotor Blades P/N 709-0103-01-101 removed for inspection (visually & tapping)**

Position	S/N	Condition
Target	EM-0343	<ul style="list-style-type: none"> <li>Paint scratches between STA 365 &amp; 445</li> <li>12 mm scratch (0.002in depth) – no voids detected</li> <li>No airworthiness compromised</li> </ul>
A	EM-0238	OK
B	EM-0435	OK
C	EM-0393	OK

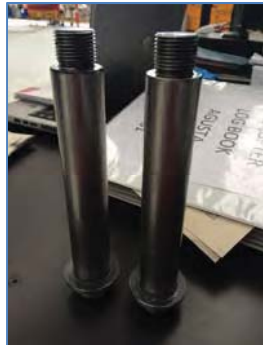
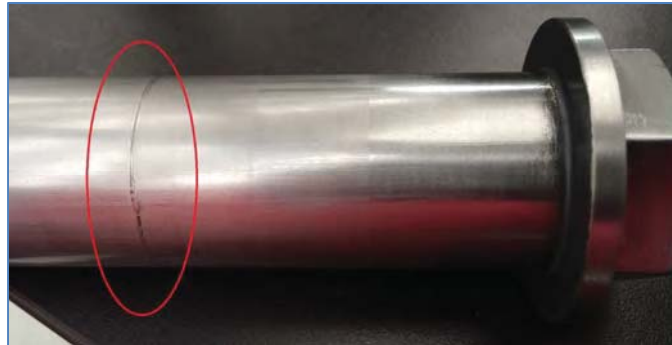
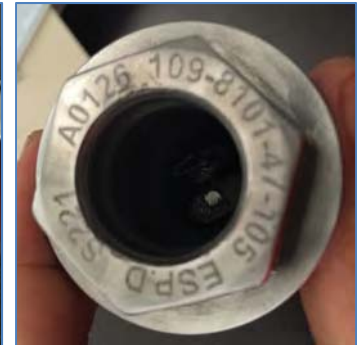
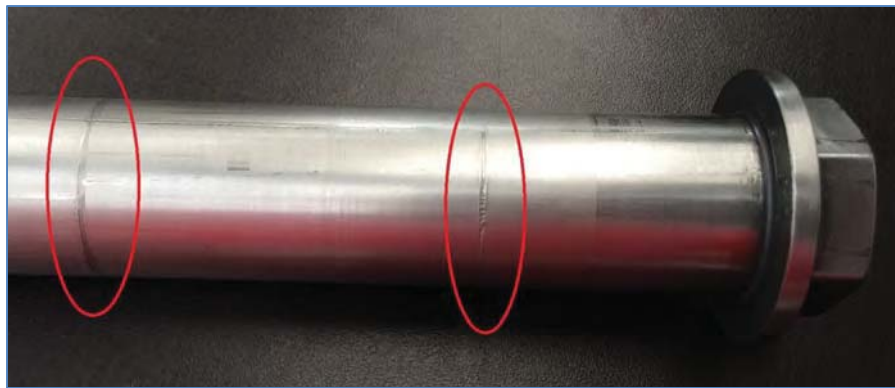
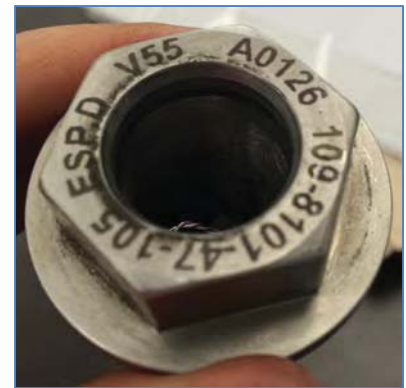
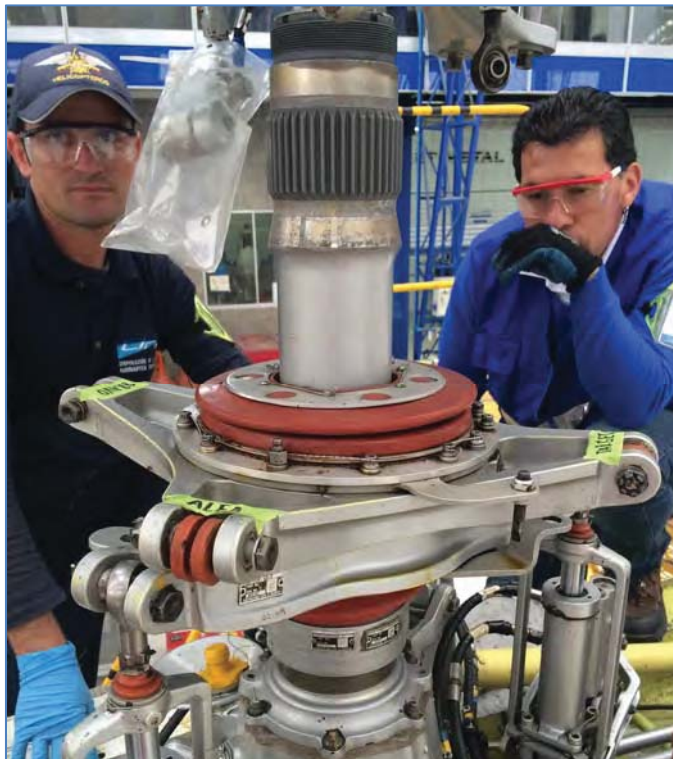
Main Rotor Blade Retention bolts inspected. 2 of them; P/N 109-8101-47-105 S/N S221 & V55 (from MRB S/N EM-0435 "B") with mechanical damages out of tolerances. Seems old discrepancy.

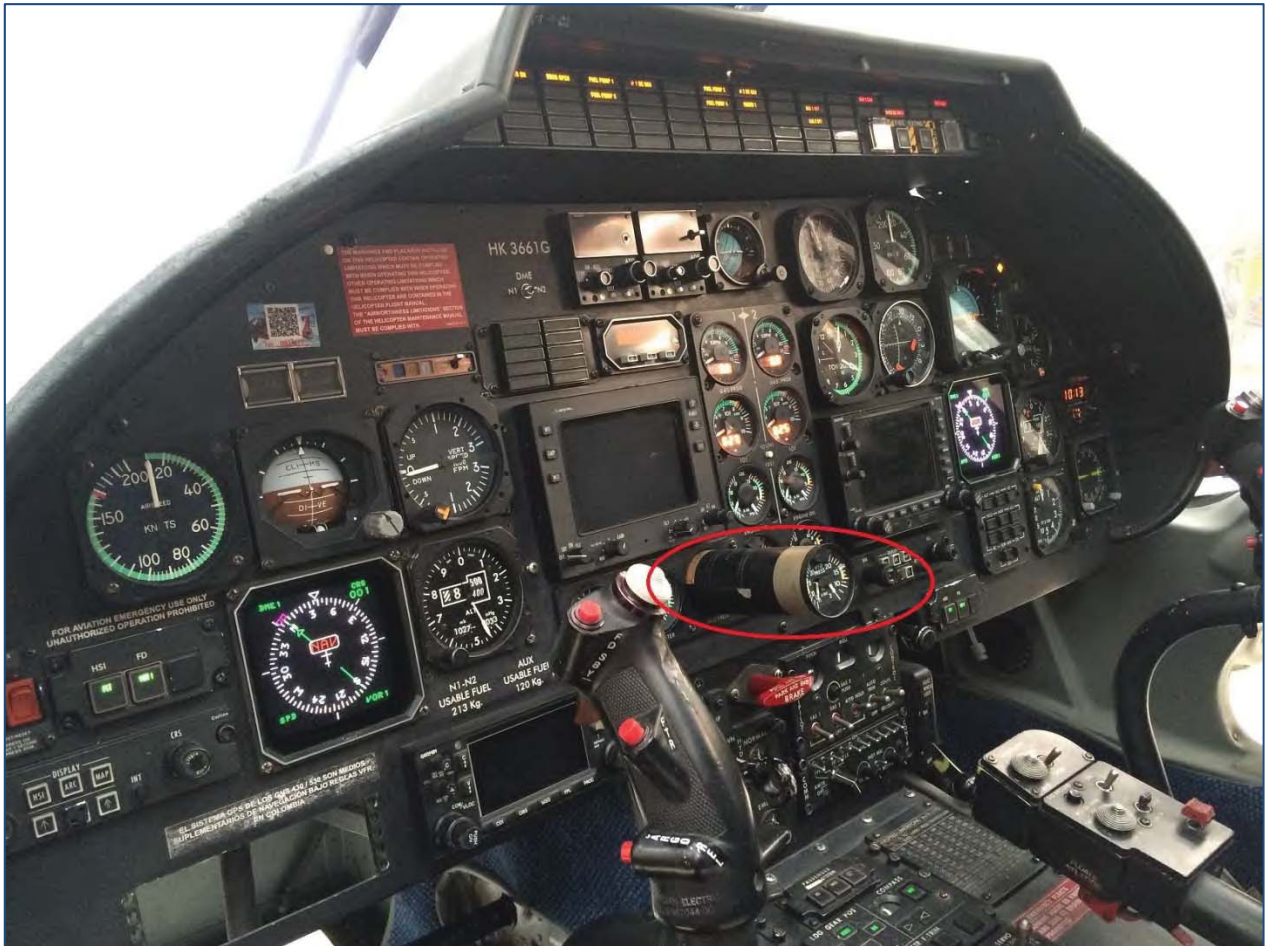
### Instrument Panel discrepancies:

- ✦ Even if the customer didn't report any engine exceedance occurred, both Turbine Outlet Temperature Indicators P/N 109-0900-14-101 show "red light" at the bottom as indication of exceedance occurred. Recommend to contact Rolls-Royce Technical Representative for additional assistance.
- ✦ Torquemeter Indicator P/N 109-0729-30-111 shows 40% from Engine #1.
