## PILES UNDERWATER INSPECTION

INSPECTION DATE: 4-jul-23

P - 01

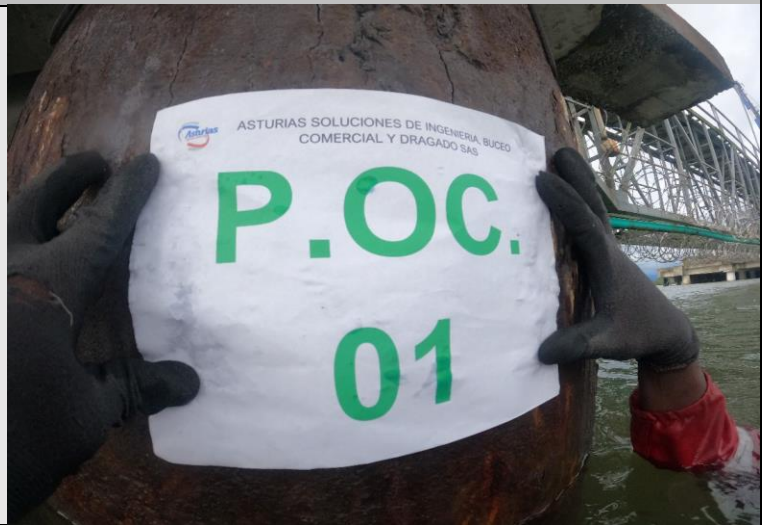
Image 1: Pile - nomenclature P-01

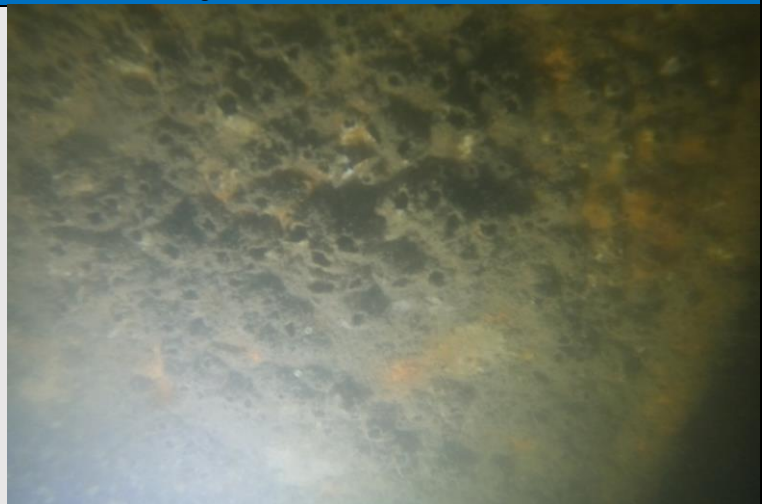
Image 2: Pile P-01 Below tide level covered largely by organisms.

Surface defects normally obscured by marine growth				
STRUCTURE STATUS / LEVEL	STEEL	CONCRETE	WOOD	COMPOSITE
I		N/A	N/A	N/A
II		N/A	N/A	N/A
III		N/A	N/A	N/A
IV	X	N/A	N/A	N/A
Observations: The structure is completely covered by marine growth

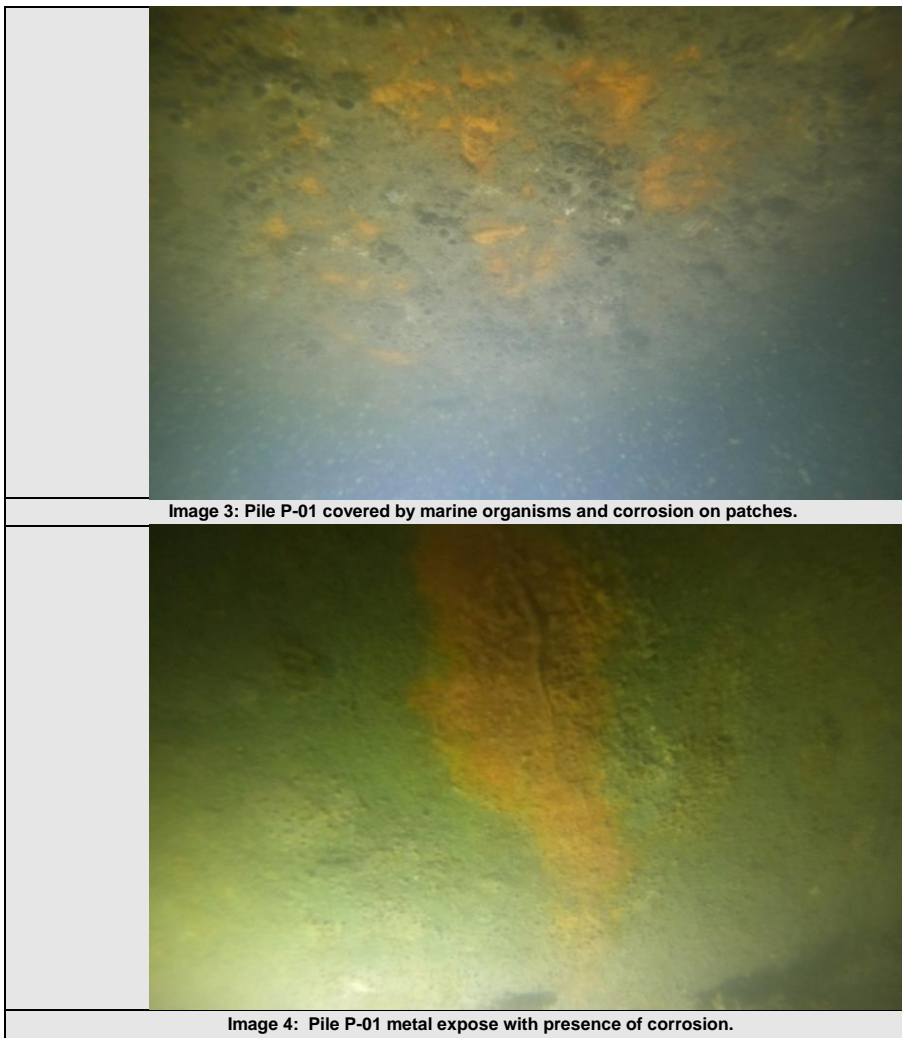
Severe Damage					Loss of cross - sectional area, or evaluate material			
STRUCTURE STATUS / LEVEL	STEEL COATING	CONCRETE	WOOD	COMPOSITE	STEEL COATING	CONCRETE	WOOD	COMPOSITE
I		N/A	N/A	N/A	N/A	N/A	N/A	N/A
II	X	N/A	N/A	N/A	N/A	N/A	N/A	N/A
III		N/A	N/A	N/A	N/A	N/A	N/A	N/A
IV		N/A	N/A	N/A	N/A	N/A	N/A	N/A
Observations: There is evidence of porosity, and corrosion on the steel coating surface.					Observations: there is no evidence of loss material.
