## PILES UNDERWATER INSPECTION

INSPECTION DATE: 4-jul-23

P - 02

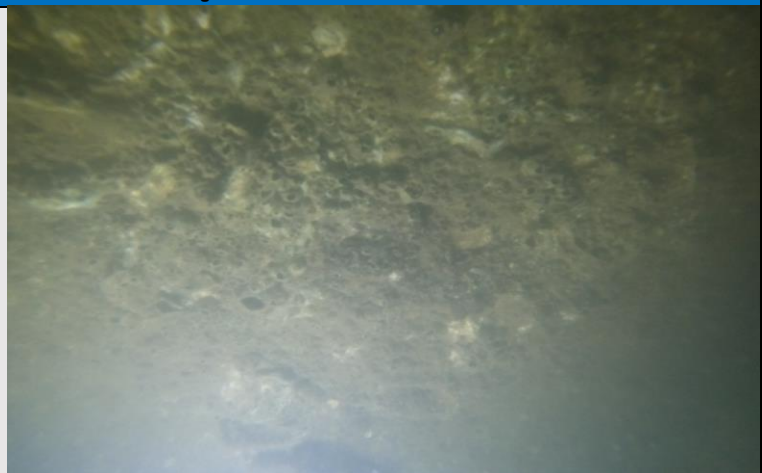
Image 2: Pile P-02 Below tide level covered largely by organisms.

Surface defects normally obscured by marine growth				
STRUCTURE STATUS / LEVEL	STEEL	CONCRETE	WOOD	COMPOSITE
I		N/A	N/A	N/A
II		N/A	N/A	N/A
III		N/A	N/A	N/A
IV	X	N/A	N/A	N/A
Observations: The structure is completely covered by marine growth

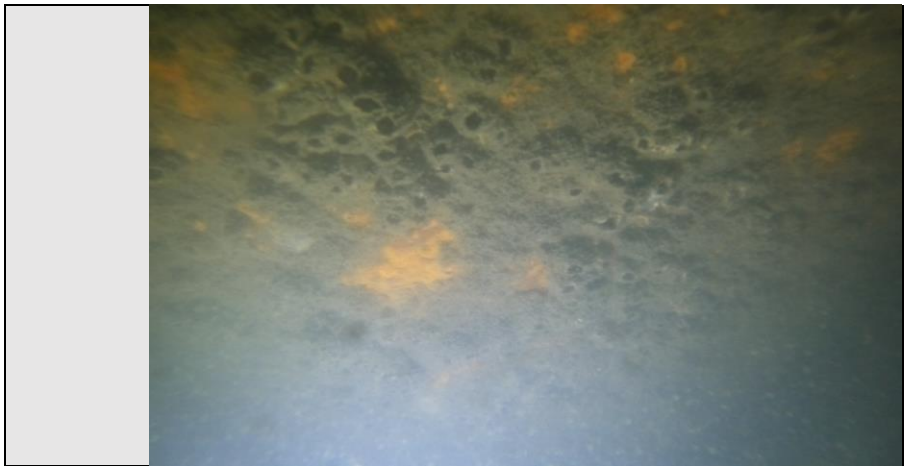
Image 3: Pile P-02 covered by marine organisms and corrosion on patches.

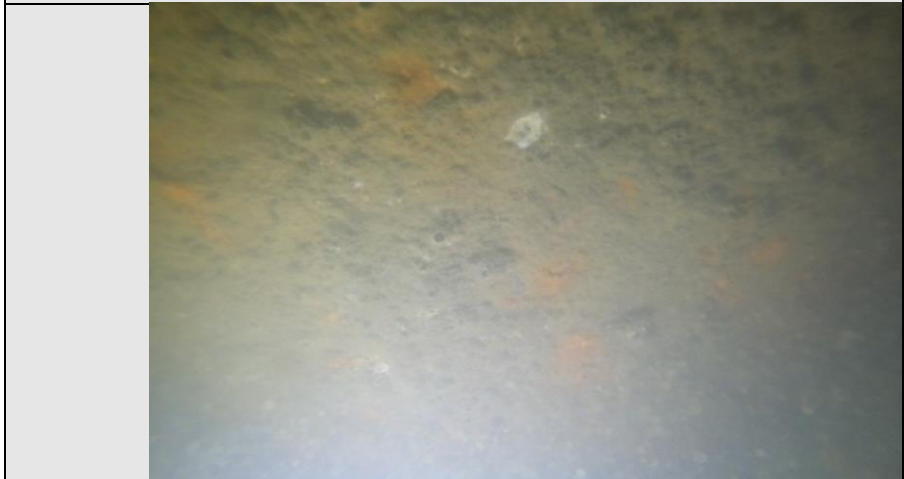
Image 4: Pile P-02 metal expose with presence of corrosion.

Severe Damage					Loss of cross - sectional area, or evaluate material			
STRUCTURE STATUS / LEVEL	STEEL COATING	CONCRETE	WOOD	COMPOSITE	STEEL COATING	CONCRETE	WOOD	COMPOSITE
I		N/A	N/A	N/A	N/A	N/A	N/A	N/A
II	X	N/A	N/A	N/A	N/A	N/A	N/A	N/A
III		N/A	N/A	N/A	N/A	N/A	N/A	N/A
IV		N/A	N/A	N/A	N/A	N/A	N/A	N/A
Observations: There is evidence of porosity, and corrosion on the steel coating surface.					Observations: there is no evidence of loss material.
