## PILES UNDERWATER INSPECTION

Date: 07/04/2023

P - 03

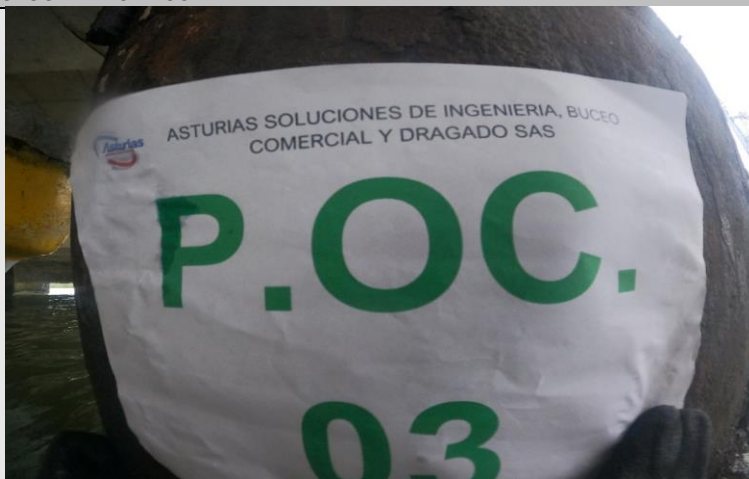
Image 1: Pile - nomenclature P-03

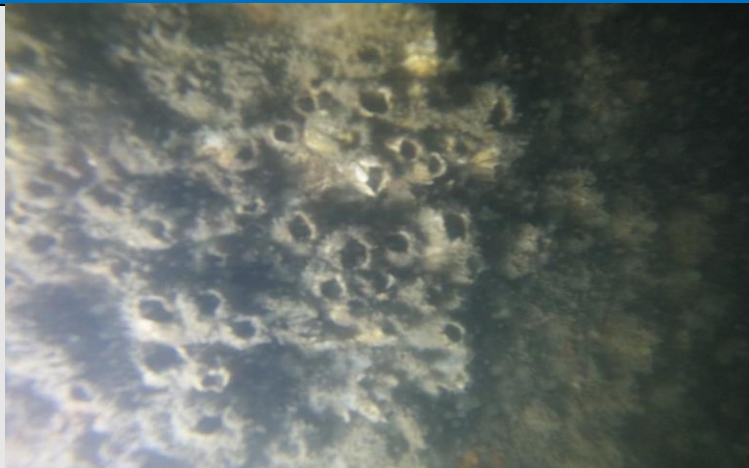
Image 2: Pile P-03 Below tide level covered largely by organisms.

Surface defects normally obscured by marine growth				
STRUCTURE STATUS / LEVEL	STEEL	CONCRETE	WOOD	COMPOSITE
I		N/A	N/A	N/A
II		N/A	N/A	N/A
III		N/A	N/A	N/A
IV	X	N/A	N/A	N/A
Observations: The structure is completely covered by marine growth

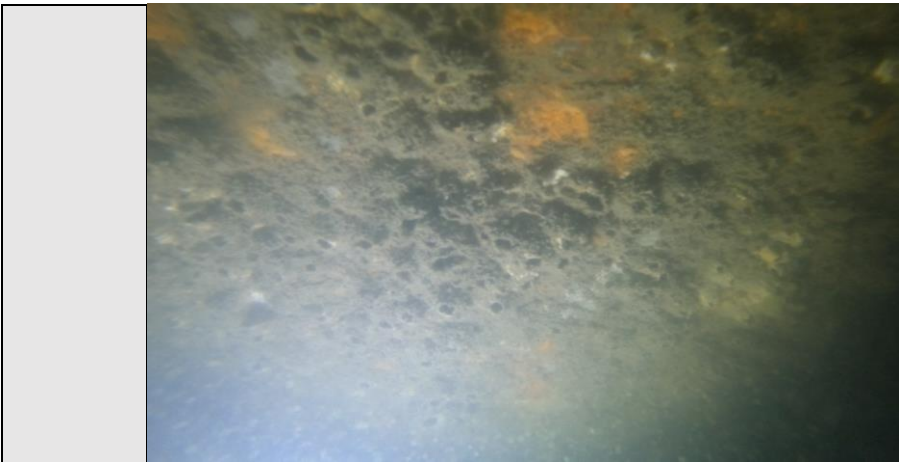
Image 3: Pile P-03 covered by marine organisms and corrosion on patches.

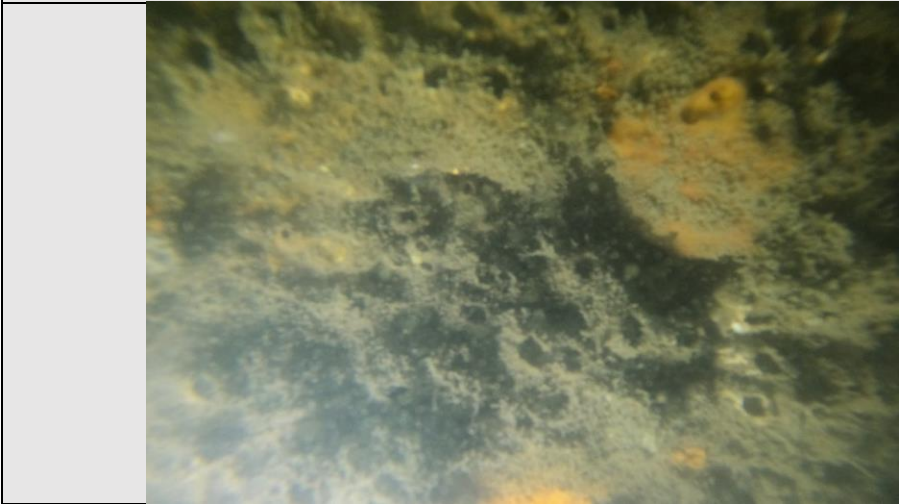
Image 4: Pile P-03 metal expose with presence of corrosion and porosity.

Severe Damage					Loss of cross - sectional area, or evaluate material			
STRUCTURE STATUS / LEVEL	STEEL COATING	CONCRETE	WOOD	COMPOSITE	STEEL COATING	CONCRETE	WOOD	COMPOSITE
I		N/A	N/A	N/A	N/A	N/A	N/A	N/A
II	X	N/A	N/A	N/A	N/A	N/A	N/A	N/A
III		N/A	N/A	N/A	N/A	N/A	N/A	N/A
IV		N/A	N/A	N/A	N/A	N/A	N/A	N/A
Observations: There is evidence of porosity, and corrosion on the steel coating surface.					Observations: there is no evidence of loss material.
