## PILES UNDERWATER INSPECTION

INSPECTION DATE: 4-jul-23

P - 04

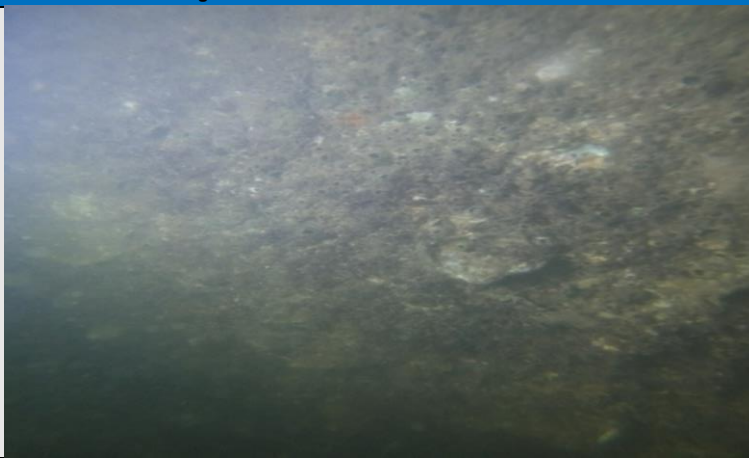
Image 2: Pile P-04 Below tide level covered largely by organisms.

Surface defects normally obscured by marine growth				
STRUCTURE STATUS / LEVEL	STEEL	CONCRETE	WOOD	COMPOSITE
I		N/A	N/A	N/A
II		N/A	N/A	N/A
III		N/A	N/A	N/A
IV	X	N/A	N/A	N/A
Observations: The structure is completely covered by marine growth

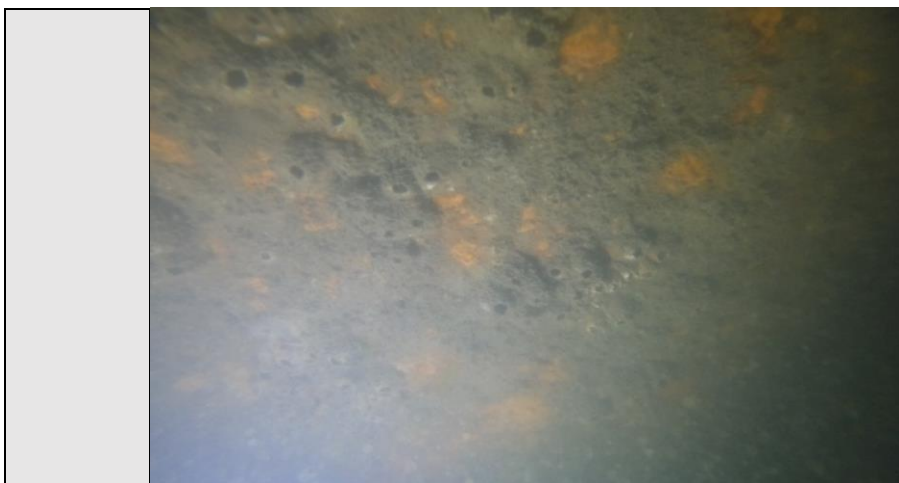
Image 3: Pile P-04 covered by marine organisms and corrosion on patches.

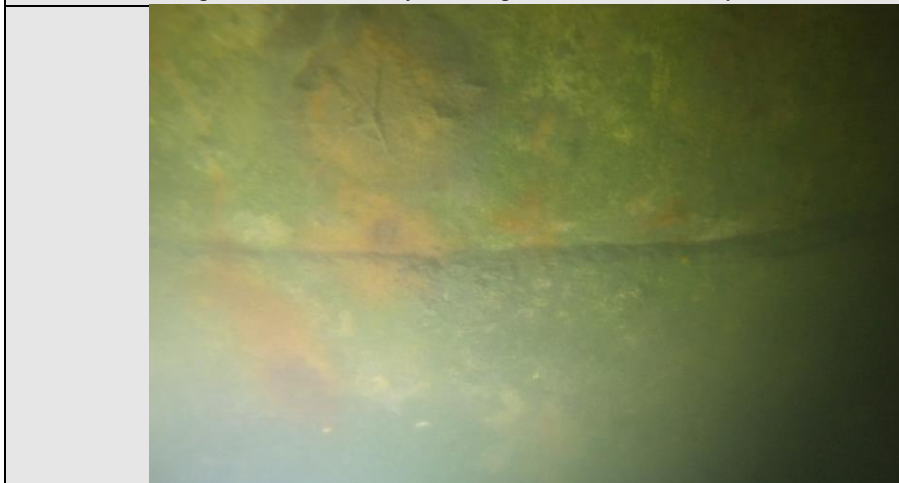
Image 4: Pile P-04 metal expose with presence of corrosion and porosity.

Severe Damage					Loss of cross - sectional area, or evaluate material			
STRUCTURE STATUS / LEVEL	STEEL COATING	CONCRETE	WOOD	COMPOSITE	STEEL COATING	CONCRETE	WOOD	COMPOSITE
I		N/A	N/A	N/A	N/A	N/A	N/A	N/A
II	X	N/A	N/A	N/A	N/A	N/A	N/A	N/A
III		N/A	N/A	N/A	N/A	N/A	N/A	N/A
IV		N/A	N/A	N/A	N/A	N/A	N/A	N/A
Observations: There is evidence of porosity, and corrosion on the steel coating surface.					Observations: there is no evidence of loss material.
