## PILES UNDERWATER INSPECTION

Date: 07/04/2023

P - 06

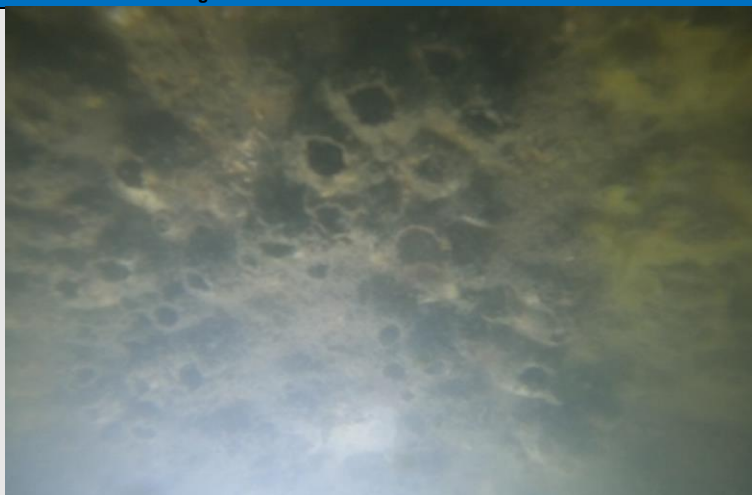
Image 2: Pile P-06 Below tide level covered largely by organisms.

Observations: The structure is completely covered by marine growth

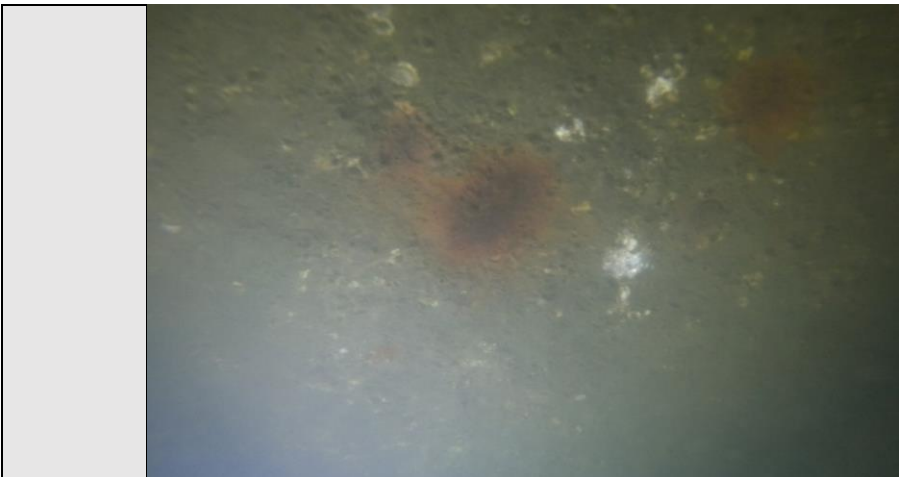
Image 3: Pile P-06 covered by marine organisms and corrosion on patches.

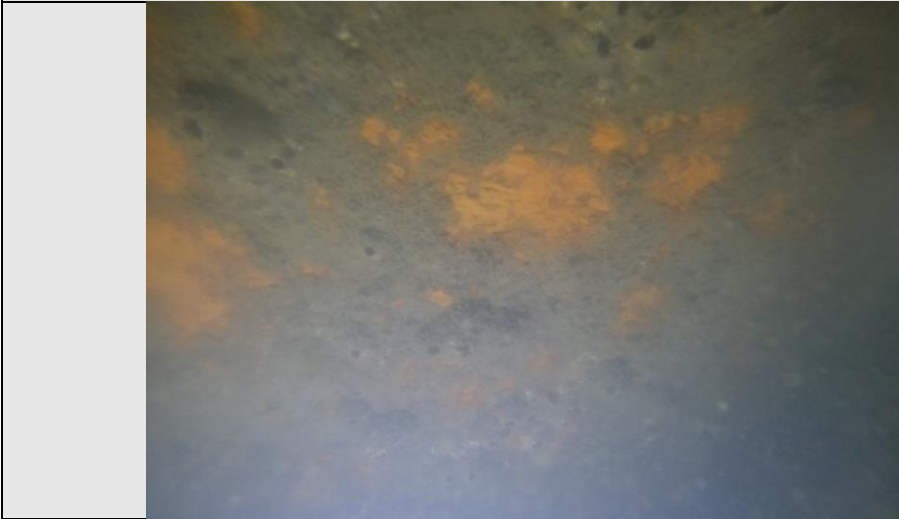
Image 4: Pile P-06 metal expose with presence of corrosion and porosity.

Observations: There is evidence of porosity, and corrosion on the steel coating surface.

Observations: there is no evidence of loss material.

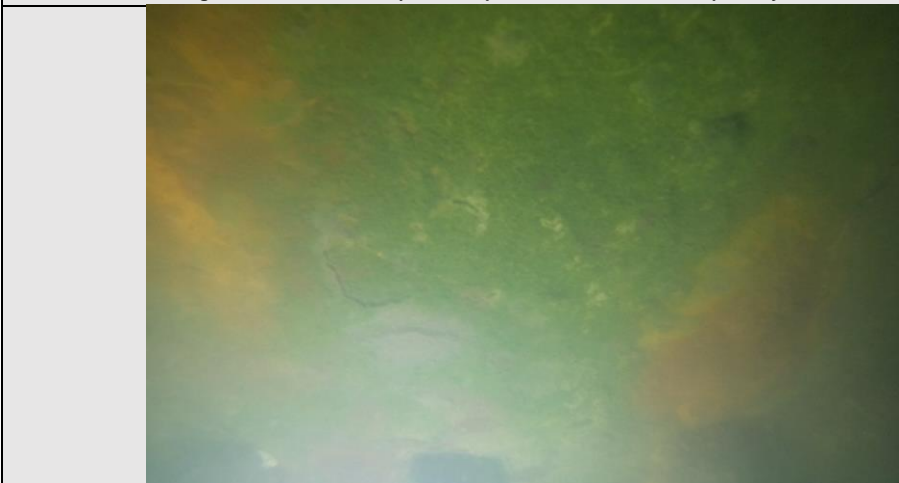
Image 5: Pile P-06 metal expose with presence of corrosion and porosity.
