PILES UNDERWATER INSPECTION

INSPECTION DATE: 4-jul-23

P - 07

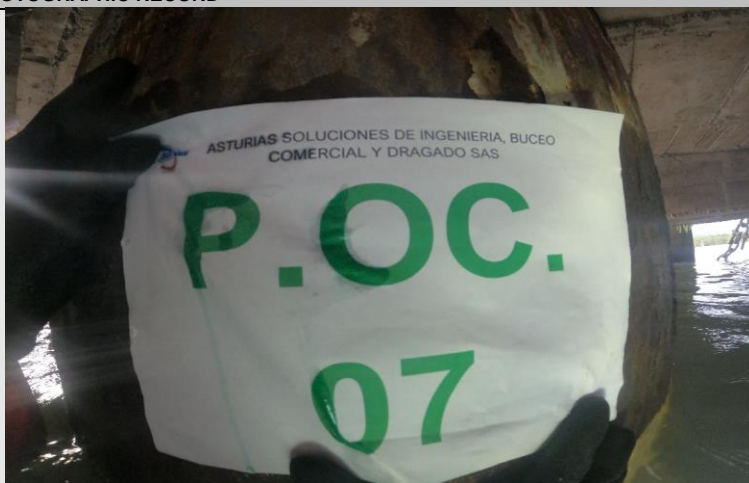
Image 1: Pile - nomenclature P-07

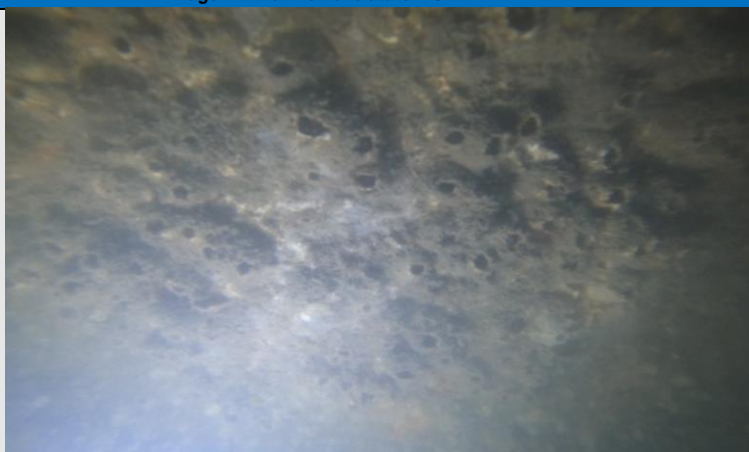
Image 2: Pile P-07 Below tide level covered largely by organisms.

Surface defects normally obscured by marine growth				
STRUCTURE STATUS / LEVEL	STEEL	CONCRETE	WOOD	COMPOSITE
I		N/A	N/A	N/A
II		N/A	N/A	N/A
III		N/A	N/A	N/A
IV	X	N/A	N/A	N/A
Observations: The structure is completely covered by marine growth

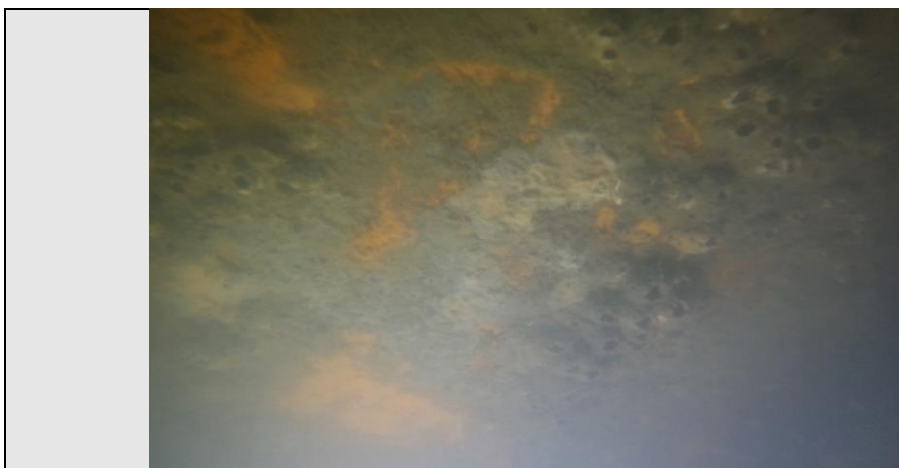
Image 3: Pile P-07 covered by marine organisms and corrosion on patches.

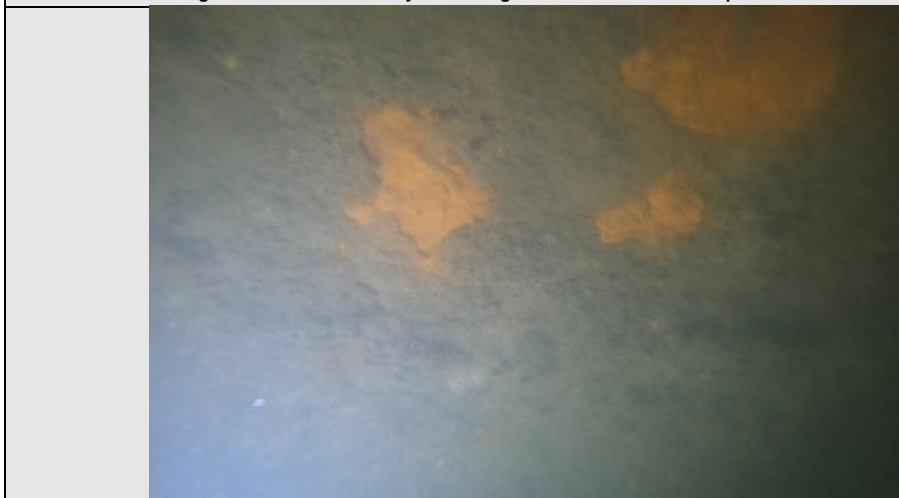
Image 4: Pile P-07 metal expose with presence of corrosion and porosity.

Severe Damage					Loss of cross - sectional area, or evaluate material			
STRUCTURE STATUS / LEVEL	STEEL COATING	CONCRETE	WOOD	COMPOSITE	STEEL COATING	CONCRETE	WOOD	COMPOSITE
I		N/A	N/A	N/A	N/A	N/A	N/A	N/A
II	X	N/A	N/A	N/A	N/A	N/A	N/A	N/A
III		N/A	N/A	N/A	N/A	N/A	N/A	N/A
IV		N/A	N/A	N/A	N/A	N/A	N/A	N/A
Observations: There is evidence of porosity, and corrosion on the steel coating surface.					Observations: there is no evidence of loss material.
