PILES UNDERWATER INSPECTION

Date: 07/04/2023

P - 09

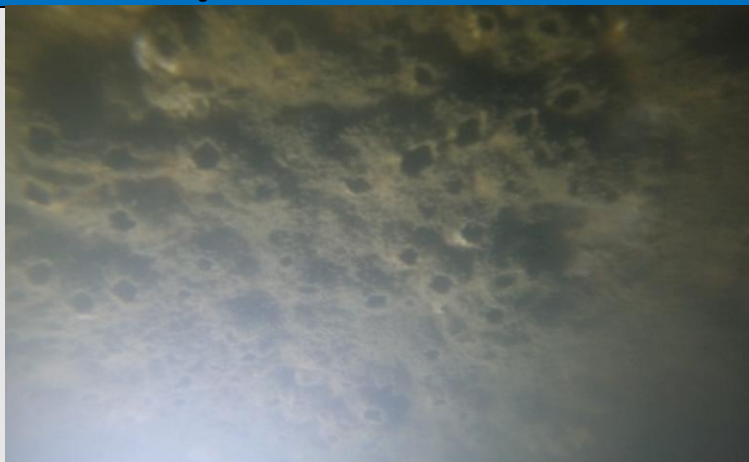
Image 2: Pile P-09 Below tide level covered largely by organisms.

Surface defects normally obscured by marine growth				
STRUCTURE STATUS / LEVEL	STEEL	CONCRETE	WOOD	COMPOSITE
I		N/A	N/A	N/A
II		N/A	N/A	N/A
III		N/A	N/A	N/A
IV	X	N/A	N/A	N/A
Observations: The structure is completely covered by marine growth

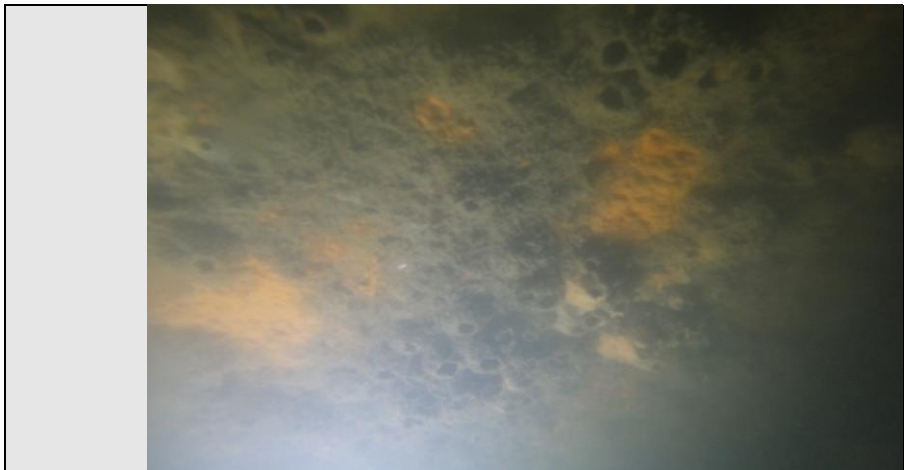
Image 3: Pile P-09 covered by marine organisms and corrosion on patches.
