TO :	<b>CIAC</b>	Date:	09/03/2016
Attn. :		Pag. (incl.this page):	19
Fax :		Our ref :	PSEAW109/2016/46322/159424
Ref. :	A109C IETP A109C S/N 7629 Aircraft Damage Evaluation (Annex A)	From:	<b>AW109 Product Support Engineering</b>
		Phone:	+1 215-268-9151
		Fax:	+1 215-281-0447
		e-mail:	<a href="mailto:micael.menendez@finmeccanica.com">micael.menendez@finmeccanica.com</a>
Copy to:	AWPC109-119.PSE.mbx, Said Torres, Javier Matos		
<input type="checkbox"/> Urgent <input type="checkbox"/> For review <input type="checkbox"/> Please Comment <input type="checkbox"/> RSVP <input checked="" type="checkbox"/> For info			
<b>SUBJECT: A109C S/N 7629 (TT: 1341.6 FH) – Damage Assessment</b>

**ANNEX A**  
**A109C S/N 7629 Aircraft Damage Evaluation**

**Subject:** A109C S/N 7629 Aircraft damage evaluation**Company:** Corporacion de la Industria Aeronautica Colombiana CIAC – Bogotá COL.**Owner:** Aeronautica Civil de Colombia

**Aircraft Model:** A109C  
**Aircraft S/N:** 7629  
**Aircraft Reg. Number:** HK-3661G  
**Aircraft TT:** 1,341.6hrs  
**Aircraft Landings:** 1,319

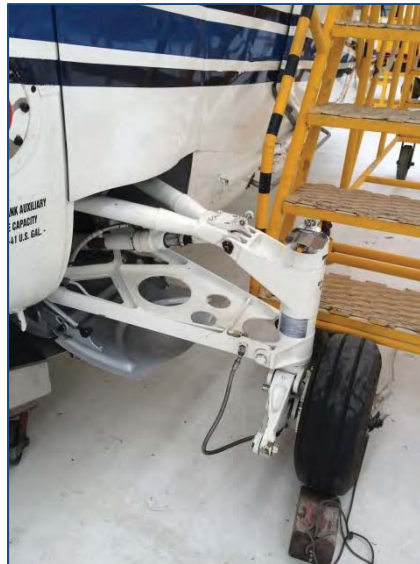
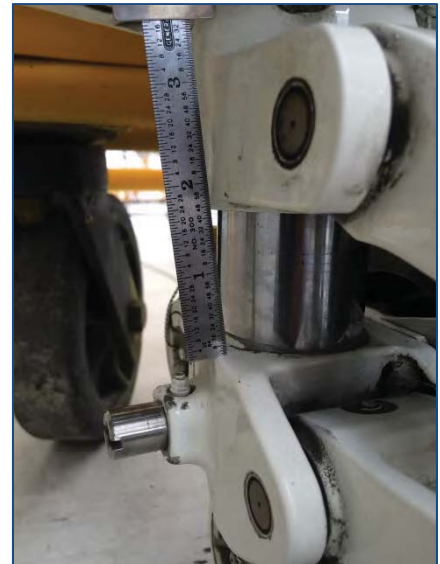
**MLG Strut Shock Absorber**  
**P/N 109-0502-86-104**  
**S/N MN47**

**Length: 1 ¾ in**

1. After Nitrogen servicing on both MLG Strut Shock Absorber IAW MM, no leaks detected. Correct length reached.
2. No discrepancies noted on NLG Strut Shock Absorber, either in the attachment area.

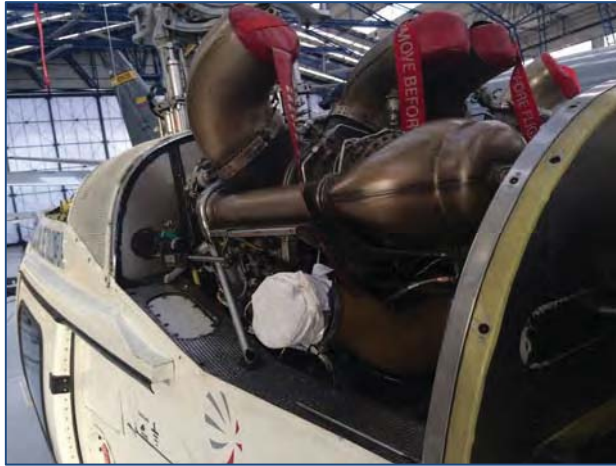
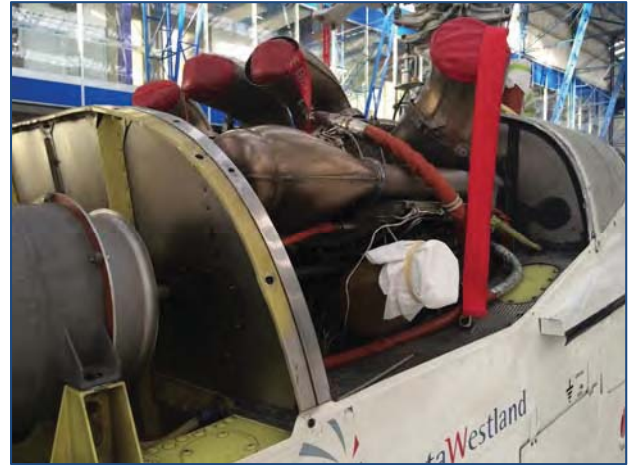
General Visual Inspection in Engines area without discrepancies noted.

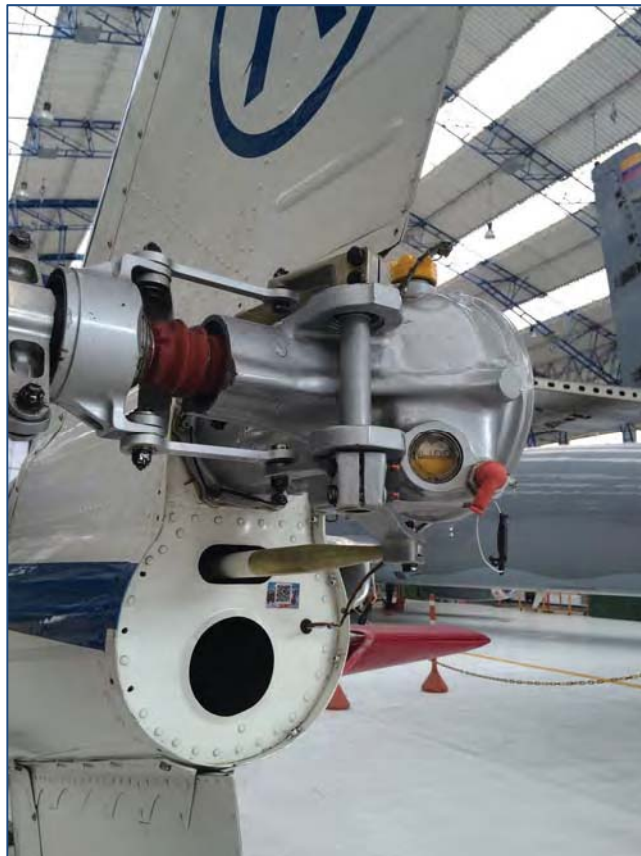
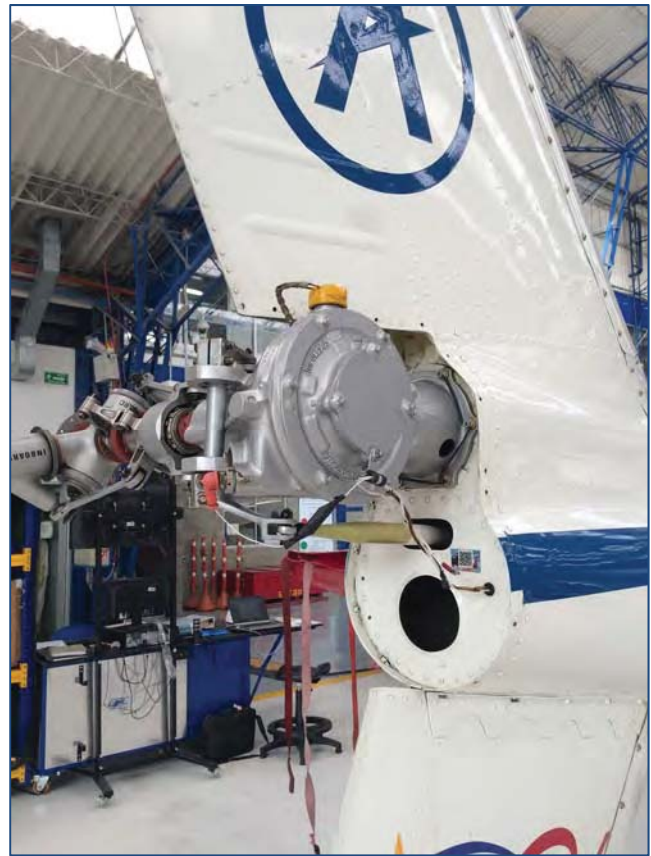
General Visual Inspection TRDS, TGB & T/R Rotating Controls without discrepancies noted. Also borescope inspection was performed inside the Tailboom, torque check to Fuselage-Tailboom attachment bolts with satisfactory results.
